November 11, 2014

Project: Carnation Garage Building on Cataldo Avenue between Washington and Howard Streets
Spokane, WA

Subject: Limited Visual Review of Structural Condition

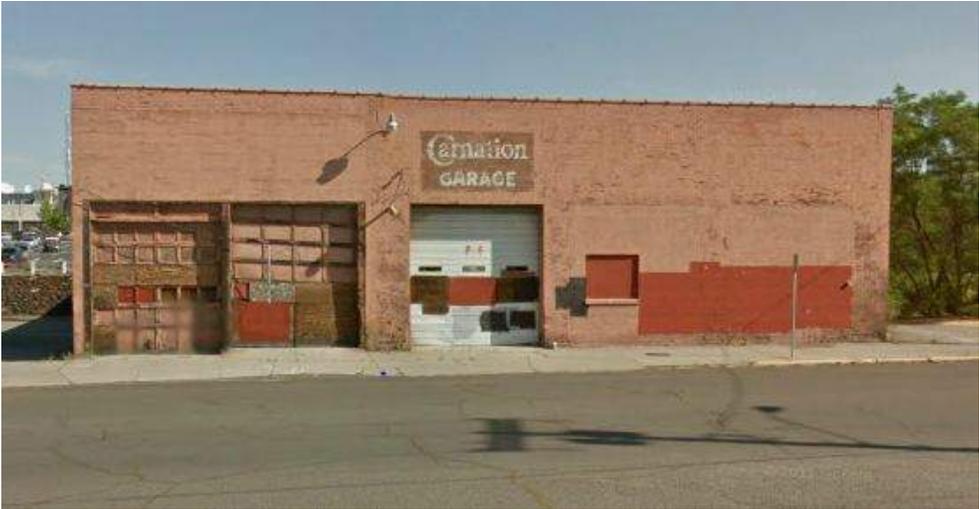
Photo 1: South Exterior Wall Facing Cataldo Avenue

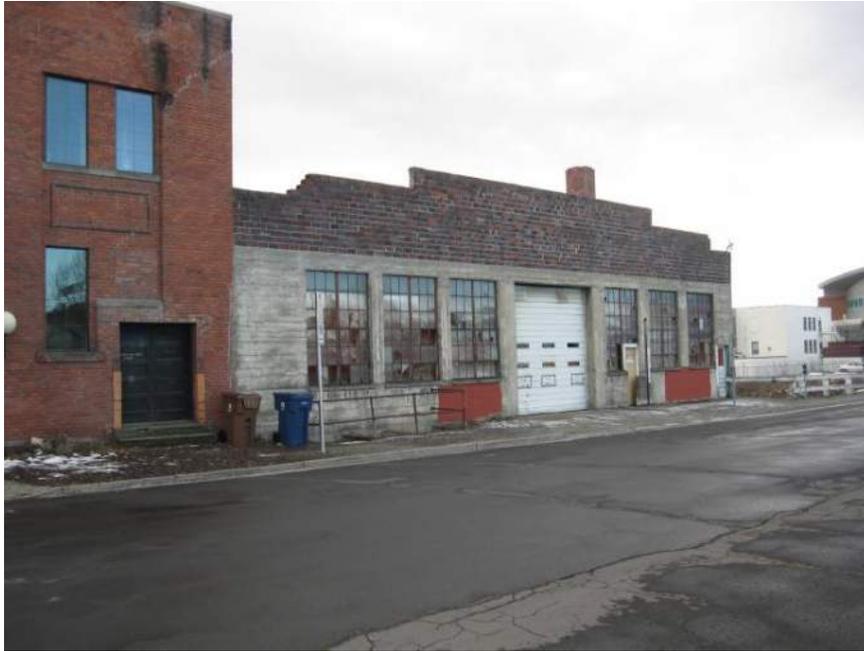
Exterior walls appear to be mainly unreinforced brick masonry with the possible exception of the north and west walls. The north and west walls appear to be concrete or concrete masonry. The walls on the north half of the building appear to have concrete column elements supporting the primary, clear-span trusses with masonry infill between columns. The north end wall has an unreinforced masonry parapet extending up from the building wall.

Photo 3: North End Exterior Wall

3. Exterior walls would require fairly extensive restoration, which would include the demolition and/or bracing of parapets, re-pointing mortar joints, and brick replacement in several areas.

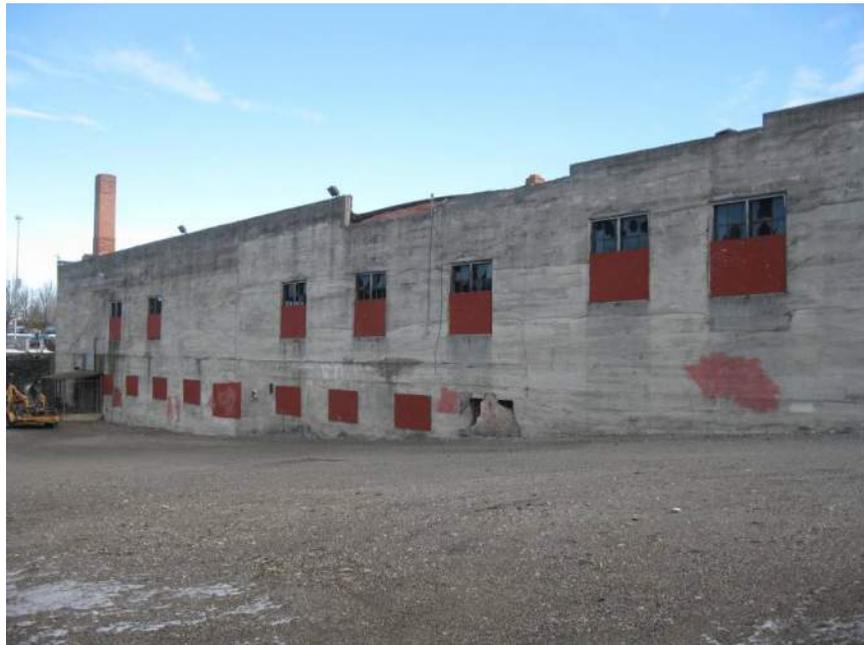
Photo 4: West Side Exterior Wall

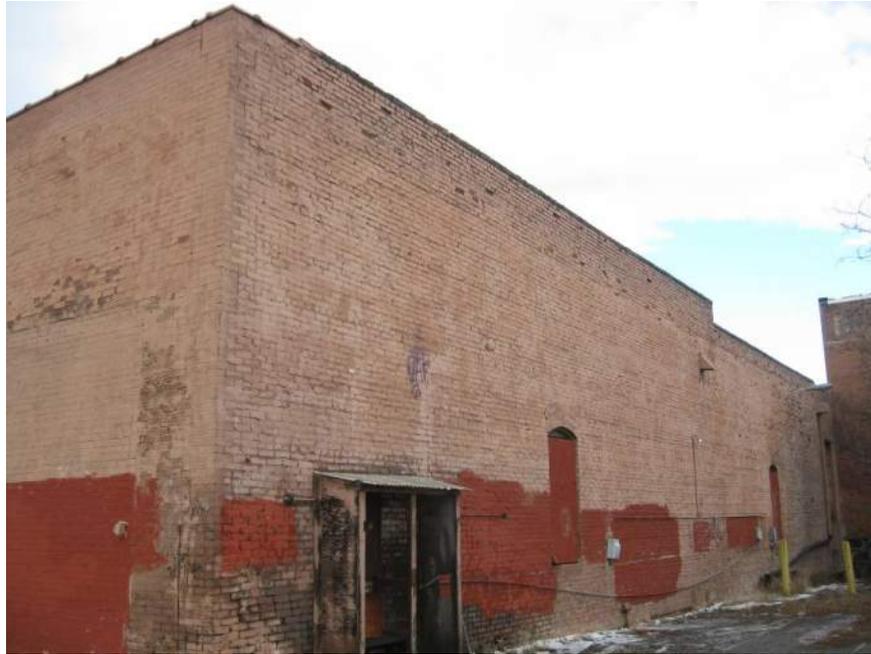
Many areas where the exterior walls were brick masonry were in need of attention. Large areas would require clean up and restoration of mortar and replacement of bricks. Areas of particular attention would be at the corners and parapets.

Photo 5: Southeast Corner Exterior Wall

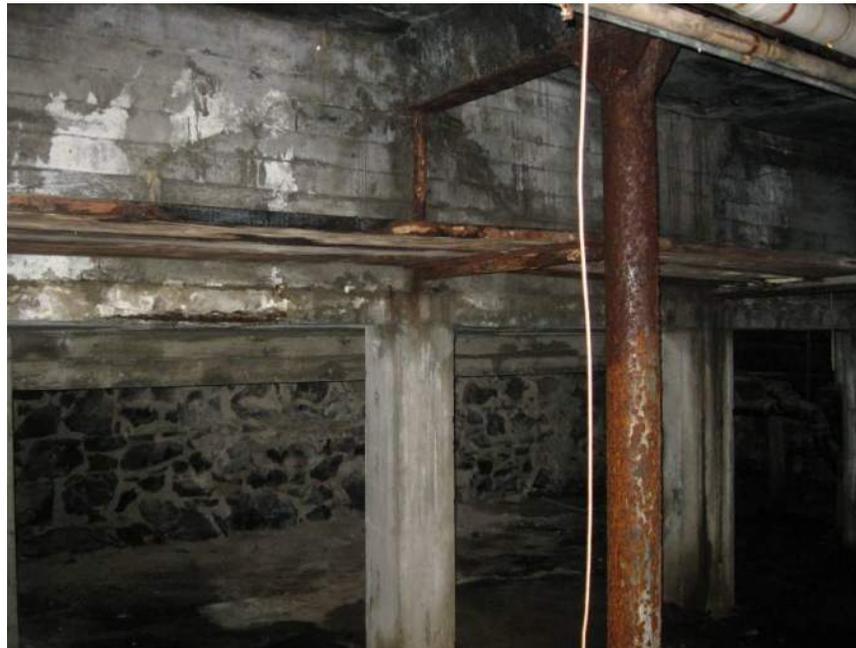
The main floor in the southern portion of the building was not in as good of shape. Contributing factors may be the traffic in this area or the substantial roof leaks. Significant corrosion was seen in exposed steel elements as well as areas of corroded reinforcing steel in slabs.

Photo 6: Main Floor Framing at South End (from lower level)

5. The main level floor would require some fairly extensive remedial work to repair or replace areas damage by exposure to moisture or other damage. This is largely isolated in the southern half of the building. Floor capacity, especially at the northern half of the building, is likely adequate for a variety of possible uses.

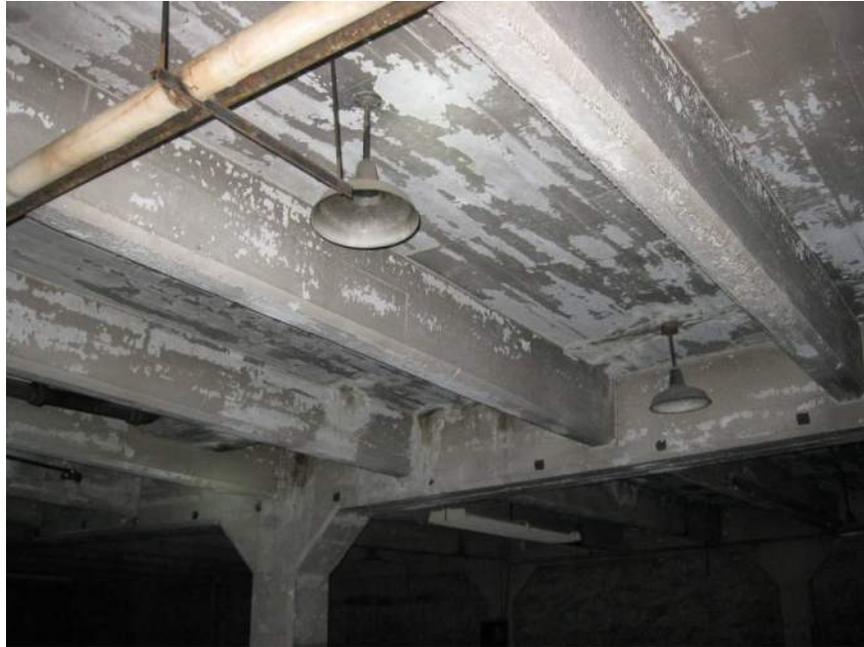
The main floor in the northern half of the building generally appeared to be in very good condition. Roof leaks do not appear to be significant enough to have caused deterioration of the floor level. From below the structural elements appear to be of a size that suggests design for traffic loads. This is consistent with our estimation of the originally-intended use.

Photo 7: Main Floor Framing at North End (from lower level)

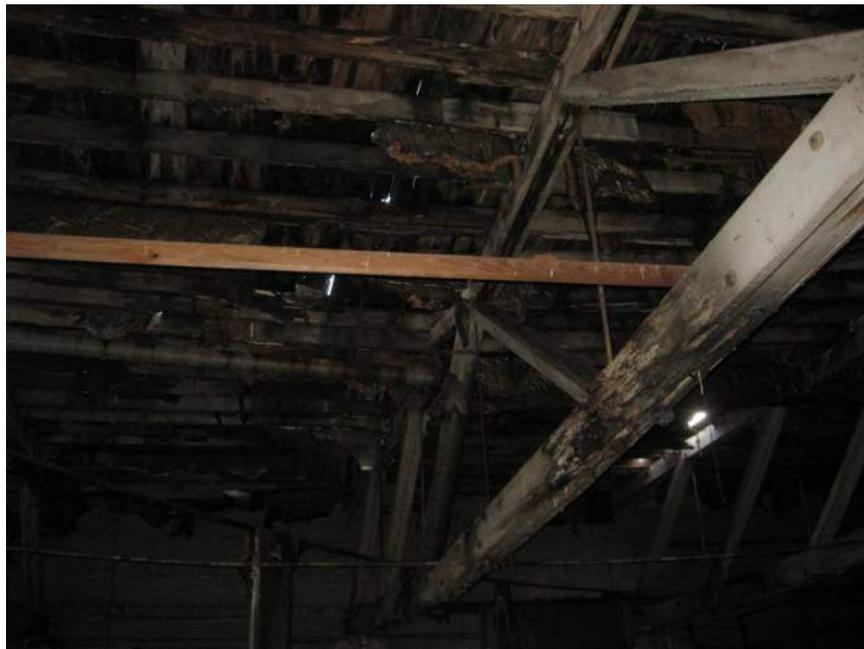
This is the area of greatest concern and we recommend the City consider blocking off all access at the main floor level until remediation efforts can be completed. The large wood trusses that span this area have decayed significantly. The decay and failure is likely due to long-term exposure to water through leaks at the roof. One primary truss in this area has nearly completely failed both at the top and bottom

chord levels and is in danger of collapsing. Large holes in the roof are visible and multiple leaking areas were evident.

Photo 8: Failed Roof Structure in Southeast Area

1. As noted above, the southeast area roof is likely in need of complete replacement. This should be addressed in the short term by blocking access to this space and then followed by consideration of long-term solutions.
2. The north area roof is in much better shape. However, even in this area there is evidence of extensive water damage that would likely require the replacement of significant portions of the roof deck and joists. In addition, the design criteria used when the building was originally constructed are likely not compliant with current code-required snow load capacity or lateral

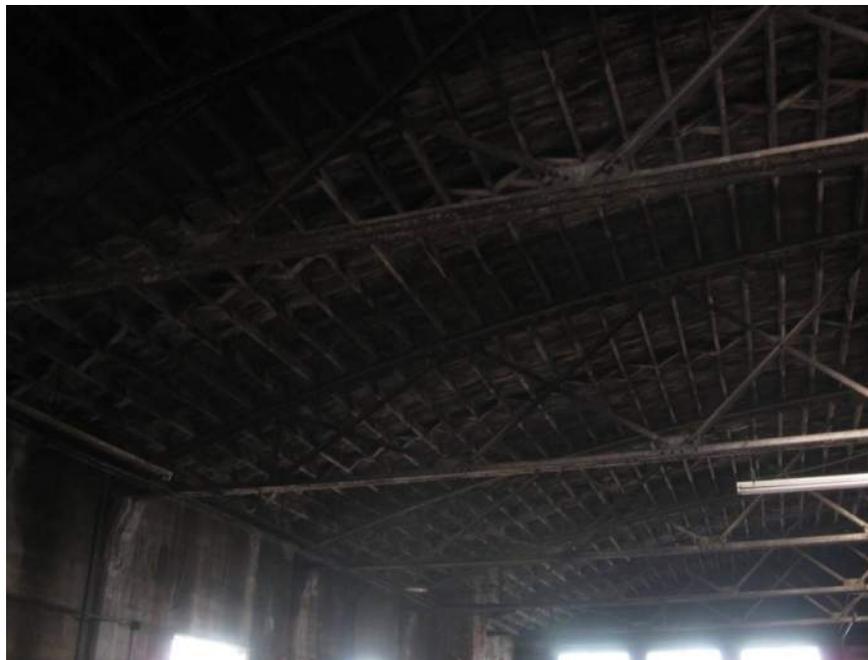
The roof is supported on clear-span steel trusses that are built up with steel angle shapes, and appears to be in generally good condition. However, the wood decking and joists shows signs of decay due to moisture penetration, likely resulting in dry rot and compromise of the structural integrity. Water staining and damp areas were visible throughout much of this area.

Photo 9: General Roof Framing at North End

forces. Examples include consideration of unbalanced snow loading on a curved roof, snow drift loading, and roof diaphragm attachments. A use change and renovation would trigger required upgrades to new standards. The likely outcome would be the necessity of structural strengthening of the steel trusses, replacement or addition of roof joists, the possible addition of plywood sheathing to create a better roof diaphragm, and the addition of ties between the roof deck and the exterior walls.

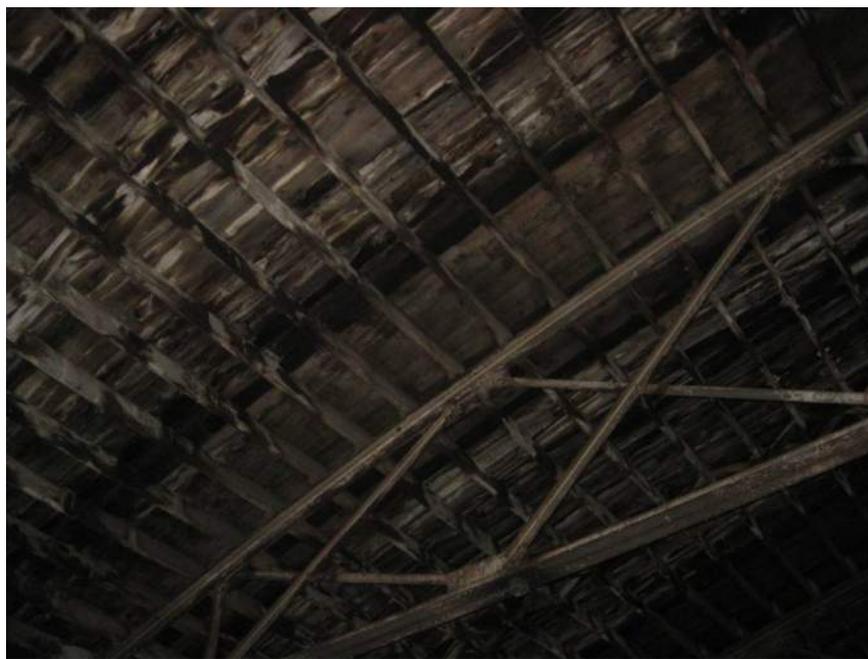
Photo 10: Typical North Area Roof Moisture Damage
